BLOWER MOTORS

NAPA® Blower Motor P/N 655-2625

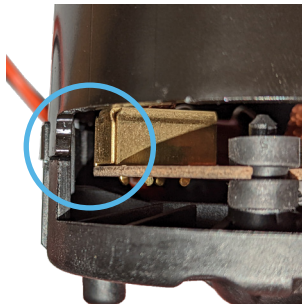
The NAPA® motor utilizes traditional tubes and brush springs. The NAPA® motor has enough clearance between the positive brush and the case which is rigidly mounted, eliminating the point of failure from the O.E. unit.

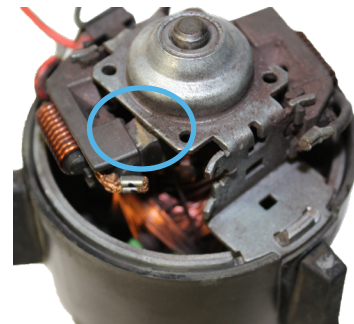
The O.E. design only includes 1 to 1.5mm of clearance between the positive brush and the grounded end case. If the positive brush hits the case, it would create a dead short to the case.

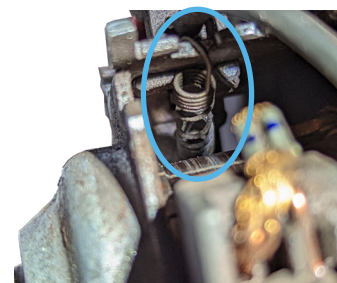
O.E. UNIT

The O.E. unit shows spring deterioration. The image on the right was taken from a vehicle with around 62,000 miles on the odometer. This deterioration leads to an unstable brush position and increases the chance the brush will contact the case.
