Diagnostic Dual Refrigerant Sight Glass Tool P/N TEM 475513

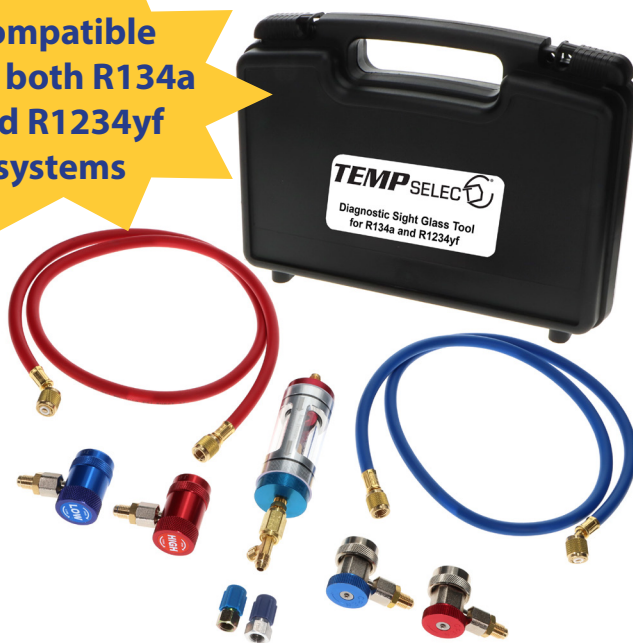
As the only sight glass tool available on the market to service both R134a and R1234yf systems, the new TEMP Select® Diagnostic Dual Refrigerant Sight Glass Tool, P/N TEM 475513, can be used before the repair to evaluate the condition of the system and to verify the presence of sealers, dyes or other contaminants. Once the repair is completed, this tool can be used to verify the system was flushed successfully and there is no remaining system debris.

**Compatible
with both R134a
and R1234yf
systems**
